(Escalator handrail sterilizer)

# A special structure lift safety study report

**Study institution: KOREA ELEVATOR SAFETY  
AGENCY**

## A special structure lift Suitability study certification

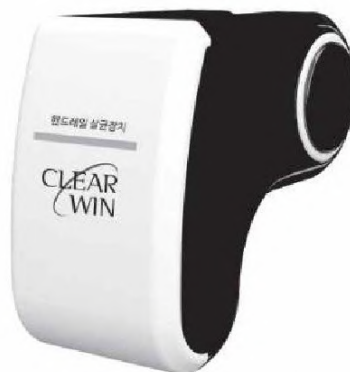
Figure 1. Escalator handrail sterilizer

○ Was applied to self-generate system.

- This product does not any connect with escalator power supply because it is operated by handrail movement.

○ Was applied to Ultraviolet sterilization system.

- This product use Ultraviolet sterilization system instead of heating or chemicals for the minimum of handrail damage. (Use the dual lamp for maximizing sterilization.)

○ Was applied to light lamp for increase recognition.

- This product is furthered visual circumstance by light indicator for people use handrail.

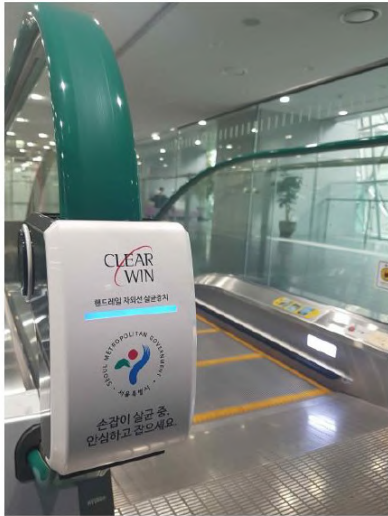
Figure 2. Product components

Sterilizer units

- A) Roller for self-generation
- B) Ultraviolet lamp for sterilization
- C) Fixing tools for Installation
- D) Cover for safety

The clearwin installed handrail's down-side with silicon materials, minimum gaps for convenience & safety like stuck hair, body, clothes

This product use ultraviolet ray instead of chemicals for sterilizing. Because damage free to handrail. (Bacteria reduced 97% per 30times sterilizing)

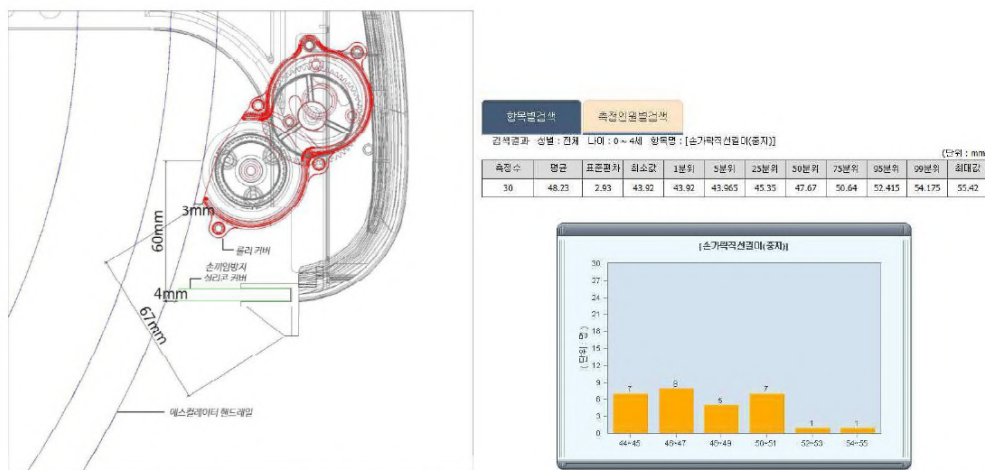
Figure 4. Roller position after due consideration about child's finger

2) 2<sup>nd</sup> prevent system (roller position)

The roller position was designed 60mm apart from guide after due consideration about a child's longest finger. (55mm)

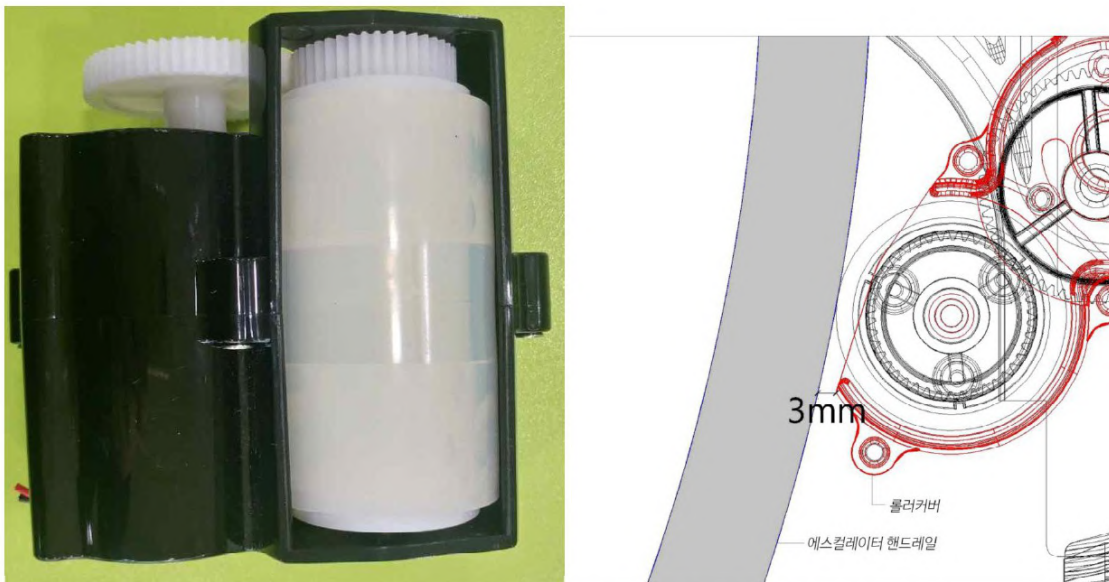
Figure 5. Roller cover (within 3mm gap)

3) 3<sup>rd</sup> prevent system (roller cover)

The roller cover was designed 3mm gap between roller cover and

handrail for prevent finger stuck.

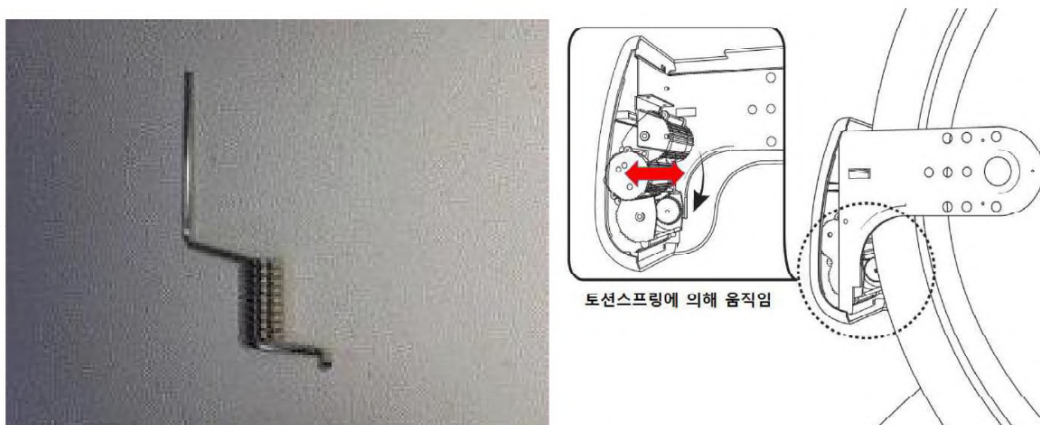
Figure 6. Torsion spring

#### 4) 4<sup>th</sup> prevent system (roller boost system)

The clearwin applied torsion spring (elasticity 0.313kgf) for body parts and clothes are caught in a handrail.

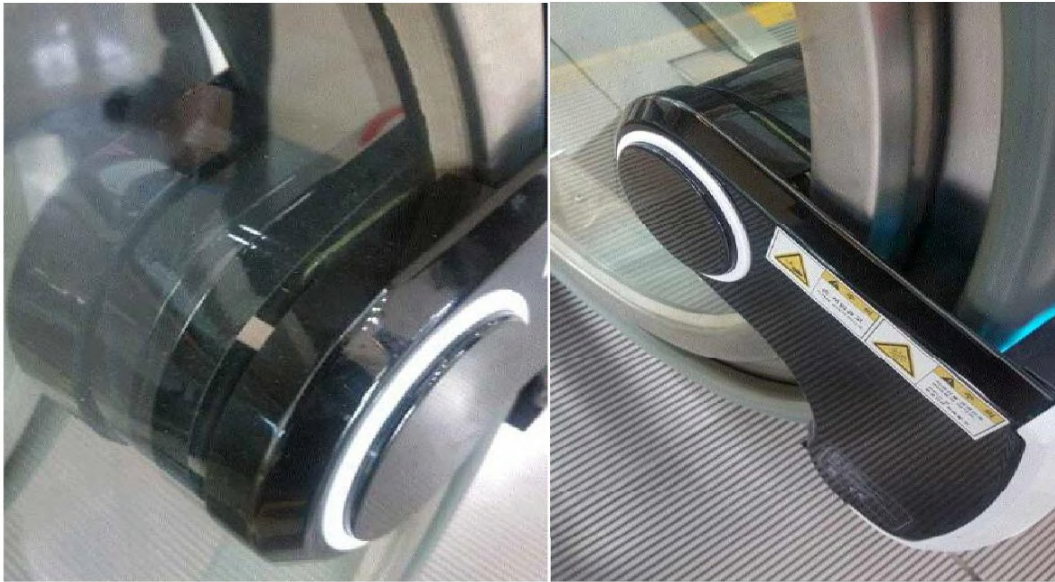
Figure 7. Fill up gap

#### B) Minimum gap between fixing part and handrail.

The gap between fixing part and handrail is 4mm for prevent body

parts and clothes from the clearwin's aging like relic.

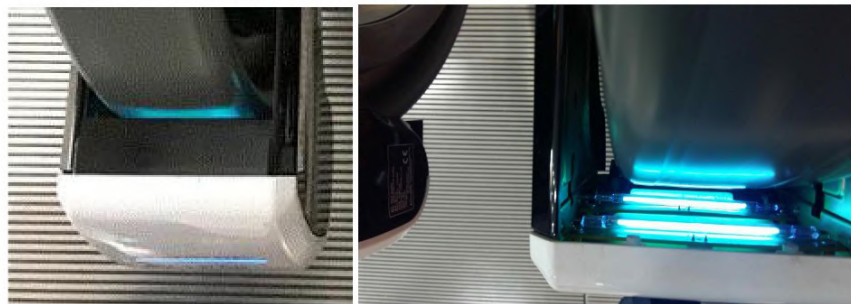
Figure 12. UV-C lamp

The clearwin use 253.7mm\* wave UV-C lamp for increase inactivation rate. At the same time, it was designed that sterilization range was 20mm. And also, the clearwin applied lamp cover that can increase safety.
